## ULT FREEZER BEST PRACTICE: IMPACTS

EPPENDORF F570H PERFORMANCE, UNIVERSITY OF BRISTOL

ANDY EVANS - GREEN LIGHT LABORATORIES LTD

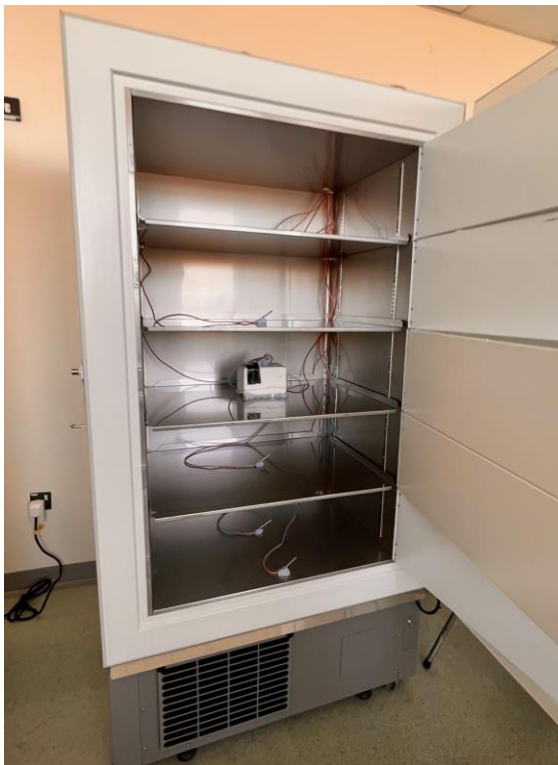
Quantifying the impact of bad practice was carried out at the Learning and Research Centre, University of Bristol. The study was jointly commissioned by Scientific Laboratory Supplies Ltd (SLS) and Eppendorf UK. The ULT freezer tested was the Eppendorf F570h. The laboratory space used was air conditioned with an ambient of 23°C (+/-1.5°C). This case study used the LogicalI Wireless Monitoring system utilizing their energy monitors, temperature probes and online platform to record all the data. In each compartment a UKAS calibrated PT1000 probe was placed in the centrepont of each shelf (figure 1).

Figure 1. The F570h fitted with PT1000 probes and energy monitor.

Furthermore, additional probes were positioned at the back of the top compartment (compartment 1) and the front of the bottom compartment (compartment 5). The F570h was first tested without any poor usage/conditions. This first step in testing provided the baseline data by which the impacts of bad practice could be measured against.

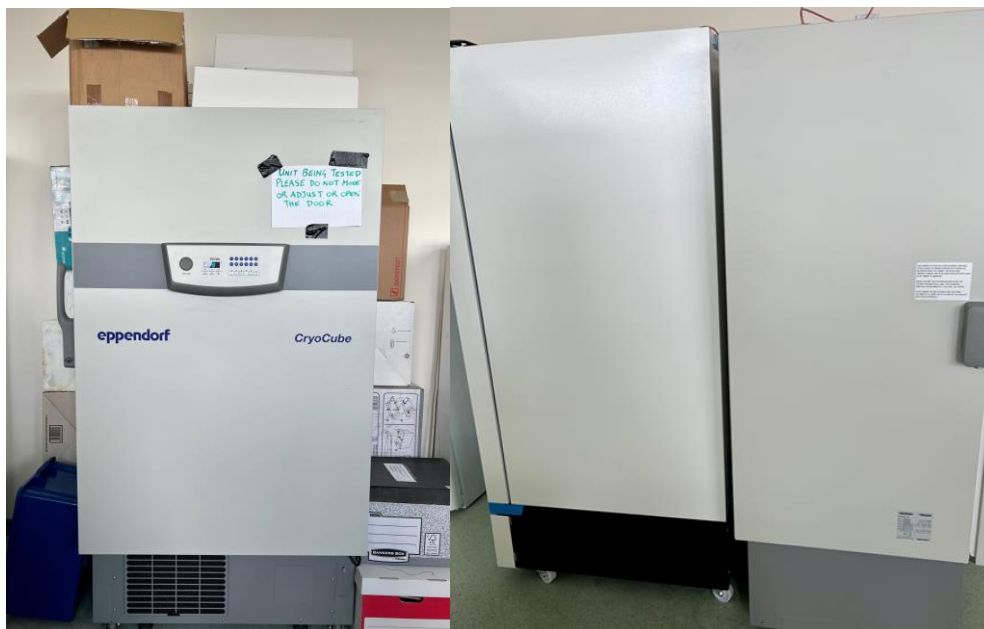
Keeping a distance of  $\geq 50\text{cm}$  at the sides and rear of the ULT freezer is another action an end user can take. Doing so provides the space for airflow, allowing the warm air ejected at the rear of the unit to rise and dissipate. To simulate poor spacing the rear of the ULT freezer was pushed flat against the wall with boxes and containers placed on top and on both sides of the freezer (figure 4).

Figure 4. On the left, poor spacing. Placing a ULT freezer back to back with another is another form of poor spacing was examined separately.

Akin to poor spacing, placing the ULT freezer away from other heat sources allows for the efficient cooling of the refrigeration system. One example of what steps not to take is placing two ULT freezers back to back (figure 4).

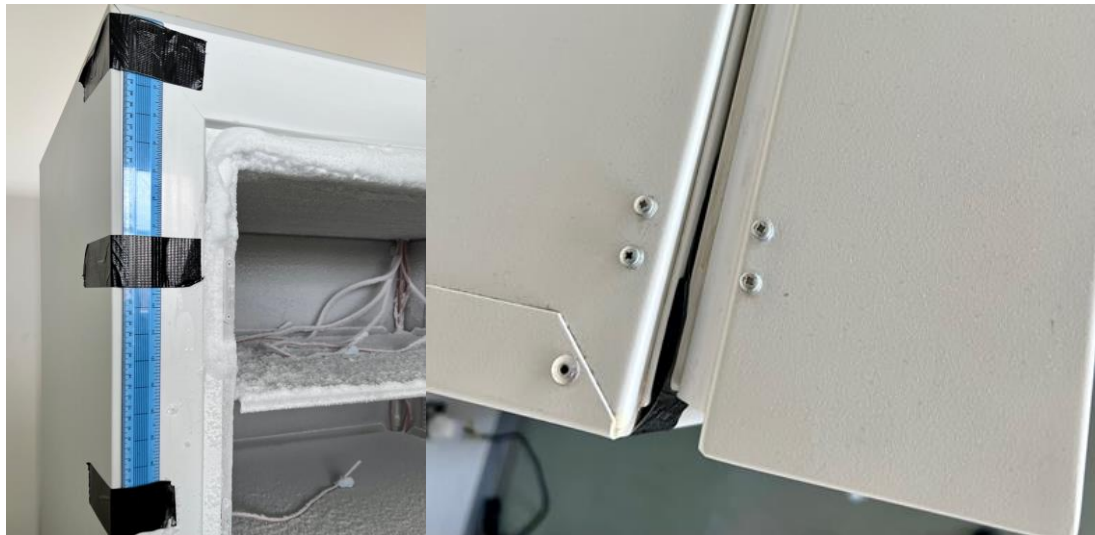
Keeping the door seal clean, unobstructed and intact helps to keep the ULT freezer chamber at the desired set temperature and reduces the build up of ice. The action taken to obstruct the door seal is shown in figure 5.

Figure 5. Left; securing the 45cm long ruler to the top left-hand side of the opened freezer created at 3.8mm gap (right) between the door seal and the freezer chamber. The obstructed seal spanned the entire height of the top freezer compartment (1) and ~50% of that of compartment 2.

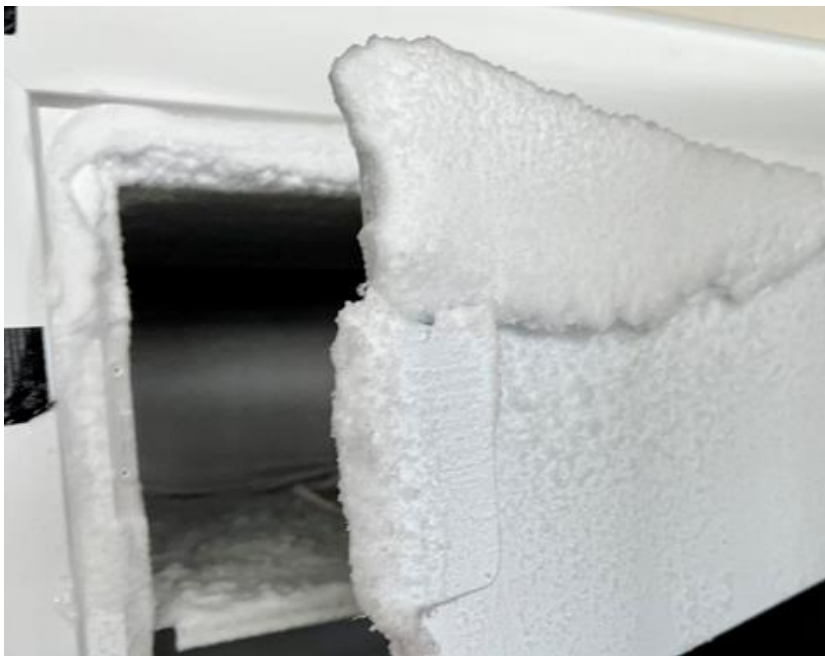
Figure 12. Icing build up progressed throughout the testing steps when the door seal was obstructed and was localized to the inner door and door frame of compartments 1 & 2.

types of bad practice it is clear that **obstruction of the door seal has the greatest impact in both the energy and temperature performance of the unit**. The energy consumption (step 6 in figure 10) increased by over **38%** and door opening recovery times increasing up to **fivefold**. It could be expected that when bad practices were combined energy consumption would also increase. However, when blocking the filter by 75% and obstructing the seal were combined (step 7, figure 10) this was not the case. One possible explanation may be icing (figure 11). Icing continued to build following the initial obstruction of the seal. This may also highlight why the temperatures in compartments 1 and 2 (figure 9) were the warmest during step 6 (door seal obstruction, only) compared to later steps where the door seal remained obstructed but other bad practices were included.
